Hazardous Materials Pre-Demolition Survey and Register 30-32 Redmyre Road, Strathfield NSW 2135

JOB NUMBER: JN04340
ISSUED DATE: 9 June 2023
PREPARED FOR: Carmichael Tompkins Property Group
CLIENT ADDRESS: Suite 9.03, Level 9, Aurora Place, 88 Phillip Street, Sydney NSW 2000
INSPECTED BY: Lee Hands Senior Hazmat Consultant
REPORT BY: Lee Hands Senior Hazmat Consultant
APPROVED BY: Alex Clark Hazmat Team Leader
ISSUE NUMBER: Rev_0

Executive Summary

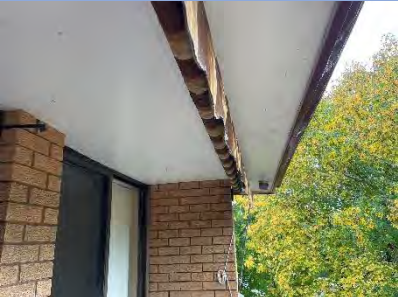
Material Identification		Risk Assessment			Risk Management & Corrective Actions			Photo
Location of Material	Description	Sample No.	Hazmat Detected / Identified	Quantity sqm, Lm, Unit	Friability	Risk Rating (H,M,L,N)		
Building Description: Two storey brick and concrete unit block with 7 units and garages								
Exterior - Common property and private Units - Eaves and balcony awnings - Soffit boards - Throughout	Asbestos Cement Board	ASB04	CH	25sqm	NF	Low	Remove by a licenced Class A or Class B asbestos removalist prior to demolition.

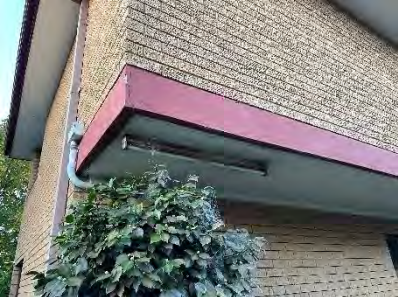
Exterior - Common property - Southern side - East and west ends - Fluorescent lights	Capacitor	SP1	Strongly presumed to contain PCB capacitors	2 light fittings	NA	Low	Isolate electricity and identify capacitor and dispose of safely as per guidance in Identification of PCB containing capacitors ANZEEC 1997

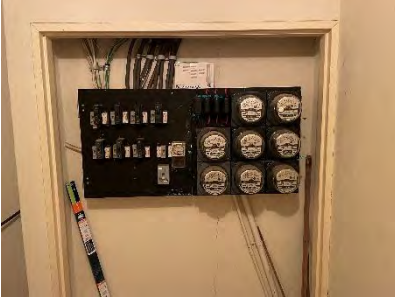
Interior - Common property - Electrical meter room - Electrical meter backing boards	Bituminous electrical board	SP2	Strongly presumed to contain Asbestos	2 boards	NF	Low	Remove by a licenced Class A or Class B asbestos removalist prior to demolition.

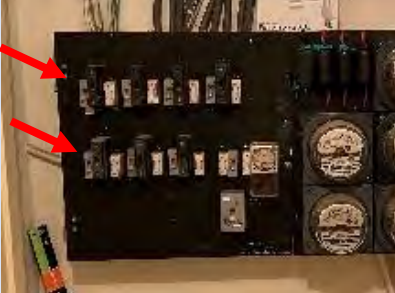
Interior - Common property - Electrical meter room - Electrical meter backing boards	Low voltage HRC fuses	SP3	Strongly presumed to contain Asbestos	7 units	F	Low	Remove by a licenced Class A asbestos removalist prior to demolition.

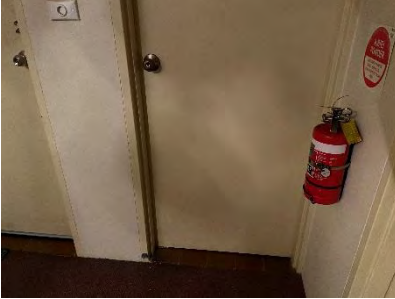
Interior - Common property - Door frames - Throughout	Cream Paint	PB08	0.11% Lead in Paint	TH	NA	Low	Maintain material in good condition and dispose of appropriately prior to demolition.

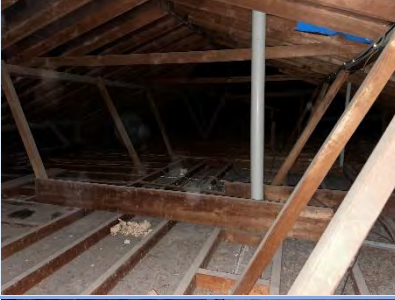
Ceiling Cavity – Upper ceiling surface - Insulation	Insulation Batts	SP4	Strongly Presumed to contain SMF	TH	NA	Negligible	Remove under controlled conditions by a competent person. PPE is to include coveralls, gloves and eye protection.

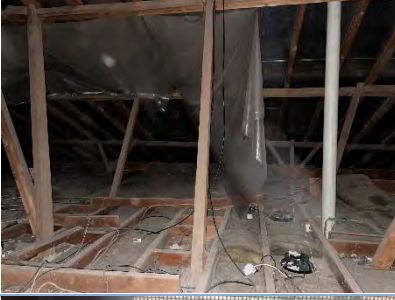
Hazardous material	General Location	Risk	Summary Recommendation
Lead Dust	Ceiling Cavity	High	Restrict access to competent persons with appropriate PPE including P2 respirator, coveralls, and gloves. Demolish building with controlled dust suppression techniques.
Brown Lead Paint	Exterior - Private Units - Balconies - Railings	Medium	Seal paint before demolition and remove railings with a localised dust control plan by competent contractors.

Ceiling Cavity – Upper surfaces	Dust	SP5	Strongly Presumed to contain lead above 4 mg/m ²	TH	NA	High	Restrict access to competent persons with appropriate PPE including P2 respirator, coveralls, and gloves. Demolish building with controlled dust suppression techniques.

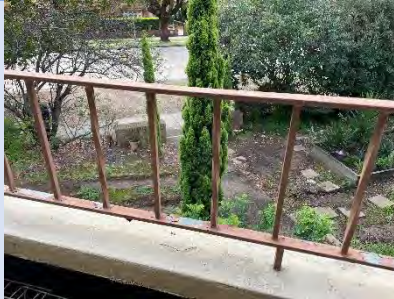
Exterior - Private Units - Balconies - Railings	Brown Paint	PB04	0.11% Lead in Paint	4sqm per balcony	NA	Medium	Seal paint before demolition and remove railings with a localised dust control plan by competent contractors.

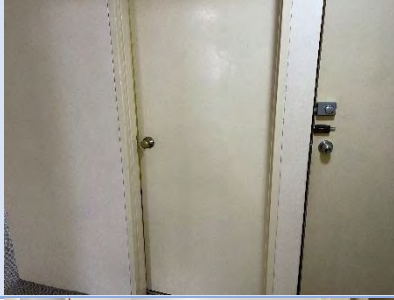
Interior - Private units - Doors and door frames	Cream paint	PB06	0.15% Lead in Paint	TH	NA	Low	Maintain material in good condition and dispose of appropriately prior to demolition.

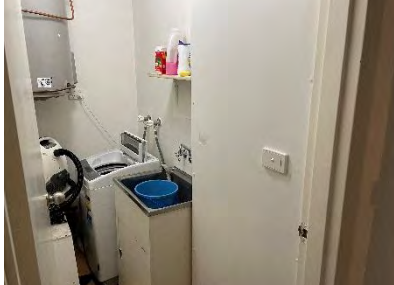
Interior - Unit 1 - Laundry - Riser	Not Determined	-	NHI	-	NA	-	No access to riser due to live electrical socket. Access riser and inspect for hazardous materials prior to demolition. Based on observations in all other units, it is considered unlikely to encounter hazardous building materials in this riser.

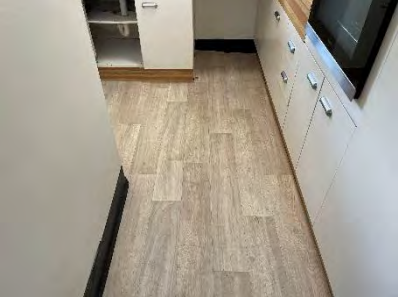
Interior - Unit 3 - Kitchen - Floor - Vinyl sheeting	Seamless Vinyl	SP6	Strongly presumed to contain SMF	6sqm	NA	Low	Remove under controlled conditions by a competent person. PPE is to include coveralls, gloves and eye protection.

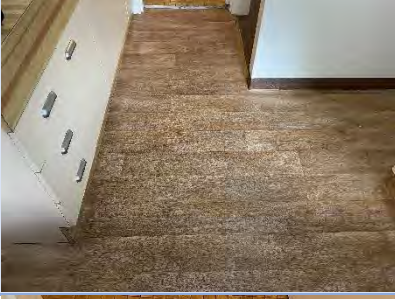
Interior - Unit 5 - Kitchen - Floor - Vinyl sheeting	Seamless Vinyl	SP8	Strongly presumed to contain SMF	12sqm	NA	Low	Remove under controlled conditions by a competent person. PPE is to include coveralls, gloves and eye protection.

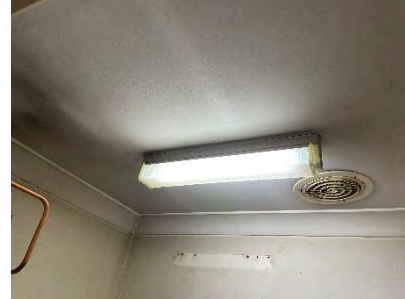
Interior - Unit 6 - Laundry - Fluorescent light	Capacitor	SP9	Strongly presumed to contain PCB capacitors	1 light fitting	NA	Low	Isolate electricity and identify capacitor and dispose of safely as per guidance in Identification of PCB containing capacitors ANZEEC 1997

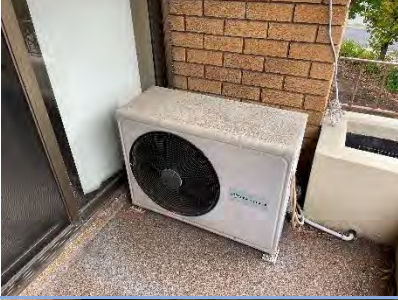
Exterior - Unit 6 Balcony - Air conditioner Unit - Email Air	Refrigerant	ODS2	R22	1.69kg	NA	Low	Handle and dispose of in accordance with Australia and New Zealand Refrigerant Handling Code of Practice 2007 - Part 1

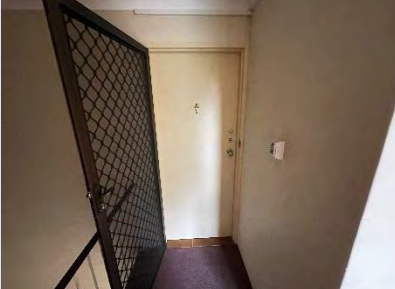
Interior - Unit 7 - Doors, door frames and skirting boards	Cream Paint	PB02	0.11% Lead in Paint	TH	NA	Low	Maintain material in good condition and dispose of appropriately prior to demolition.
