Hazardous Materials Pre-Demolition Survey and Register 30-32 Redmyre Road, Strathfield NSW 2135

JOB NUMBER: JN04340
ISSUED DATE: 9 June 2023
PREPARED FOR: Carmichael Tompkins Property Group
CLIENT ADDRESS: Suite 9.03, Level 9, Aurora Place, 88 Phillip Street, Sydney NSW 2000
INSPECTED BY: Lee Hands Senior Hazmat Consultant
REPORT BY: Lee Hands Senior Hazmat Consultant
APPROVED BY: Alex Clark Hazmat Team Leader
ISSUE NUMBER: Rev_0

Executive Summary

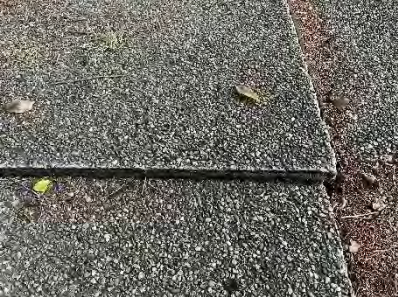
Exterior - Southern side - Common property - Driveway - Concrete slab joints	Bitumen	ASB11	NAD	-	NA	-	-

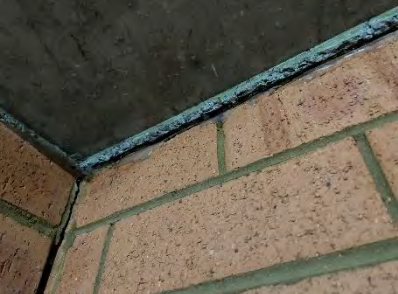
Interior - Private Units - Garages - Top of walls - between brick walls and concrete slab of floor above	Bitumen	ASB10	NAD	-	NA	-	-

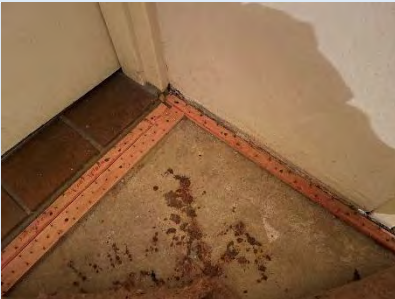
Material Identification		Risk Assessment			Risk Management & Corrective Actions			Photo
Location of Material	Description	Sample No.	Hazmat Detected / Identified	Quantity sqm, Lm, Unit	Friability	Risk Rating (H,M,L,N)		
Interior - Common property - Hallway - below carpet	Concrete	-	NHI	-	NA	-	-

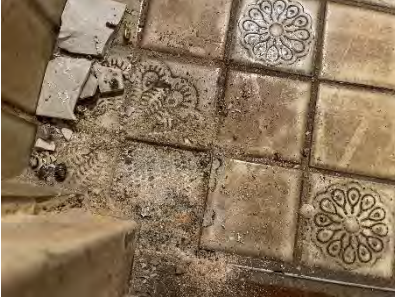
Interior - Common property - Toilet and electrical rooms - Floor - Woven webbing below floor tiles	Woven material	ASB12	NAD	-	NA	-	-

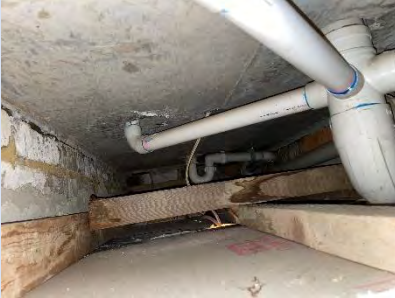
Interior - Common property – Toilet – False ceiling space	Ho hazardous materials	-	NHI	-	NA	-	-

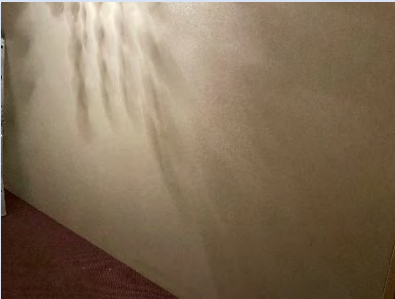
Material Identification			Risk Assessment			Risk Management & Corrective Actions		Photo
Location of Material	Description	Sample No.	Hazmat Detected / Identified	Quantity sqm, Lm, Unit	Friability	Risk Rating (H,M,L,N)		
Interior - Common property - Walls - Throughout	Cream Paint	PB07	<0.01% lead content	-	NA	-	Lead content below lead paint guideline value of 0.1%

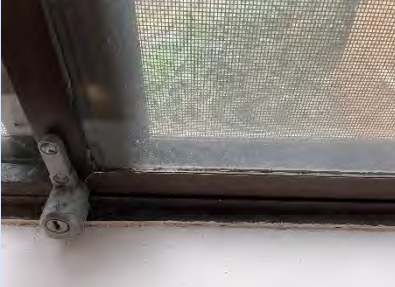
Interior - Common property and private units - Windows - Sliding windows - Throughout - Sliding windows - Sealant between frame and glass	Gasket like material	ASB01	NAD	-	NA	-	-

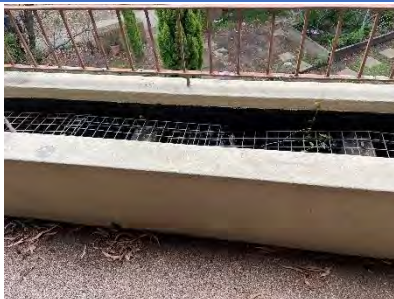
Material Identification		Risk Assessment					Risk Management & Corrective Actions	Photo
Location of Material	Description	Sample No.	Hazmat Detected / Identified	Quantity sqm, Lm, Unit	Friability	Risk Rating (H,M,L,N)		
Exterior - Private Units - Balconies - Walls	Cream Paint	PB03	0.02% lead content	-	NA	-	Lead content below lead paint guideline value of 0.1%

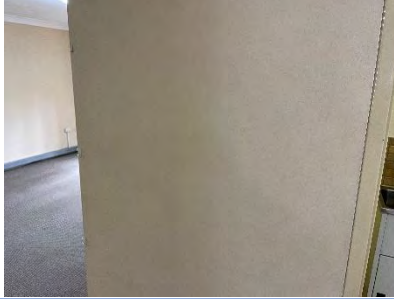
Interior - Private units - Walls	Cream Paint	PB05	<0.01% lead content	-	NA	-	Lead content below lead paint guideline value of 0.1%

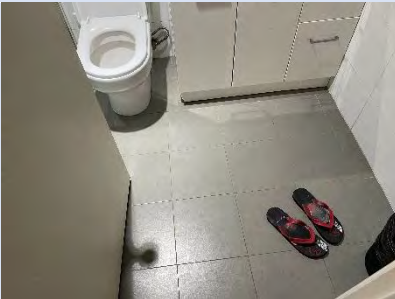
Material Identification		Risk Assessment			Risk Management & Corrective Actions			Photo
Location of Material	Description	Sample No.	Hazmat Detected / Identified	Quantity sqm, Lm, Unit	Friability	Risk Rating (H,M,L,N)		
Interior - Unit 1 - Bathroom - Walls and floor behind tiles	Not Determined	-	NHI	-	NA	-	No access behind tiles due to tenanted unit. Inspect behind tiles for hazardous materials prior to demolition. Based on observations in all other units, it is considered unlikely to encounter hazardous building materials in the bathroom.

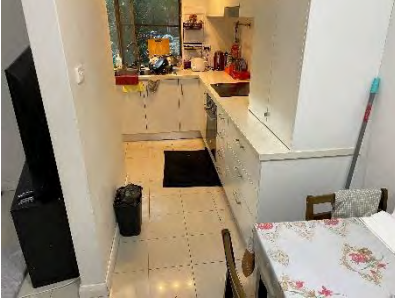
Interior - Unit 1 - Kitchen - Floor	Ceramic tiles	-	NHI	-	NA	-	Tiled floor throughout the unit. Unlikely that vinyl tiles would be below ceramic tiles.

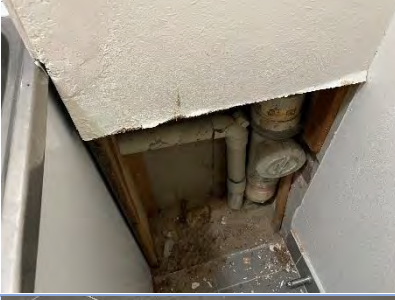
Unit 1 - Kitchen - Under draining board - Damper pad	Rubber	-	NHI	-	NA	-	-	 
Interior - Unit 2 - Laundry - Riser	No hazardous materials	-	NHI	-	NA	-	-

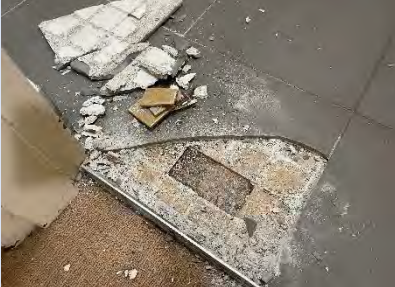
Interior - Unit 2 - Bathroom, Laundry and Kitchen - Floor	Ceramic tiles with concrete below	-	NHI	-	NA	-	-

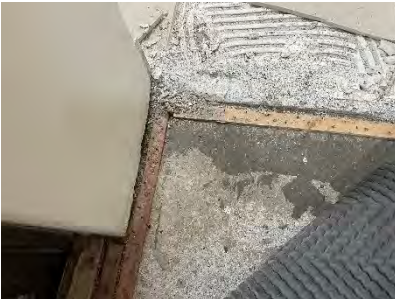
Material Identification			Risk Assessment			Risk Management & Corrective Actions		Photo
Location of Material	Description	Sample No.	Hazmat Detected / Identified	Quantity sqm, Lm, Unit	Friability	Risk Rating (H,M,L,N)		
Interior - Unit 2 - Living and bedrooms - Floor - Under carpet	Concrete	-	NHI	-	NA	-	-

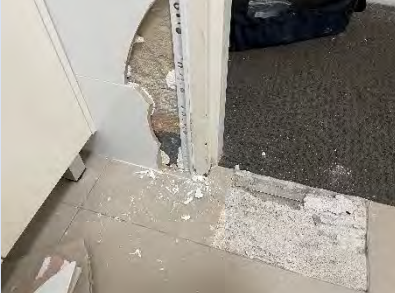
Interior - Unit 3 - Bathroom, Laundry and Kitchen - Floor	Ceramic tiles with concrete below	-	NHI	-	NA	-	-

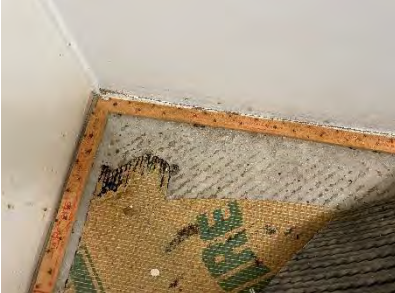
Interior - Unit 3 - Living and bedrooms - Floor - Under carpet	Concrete	-	NHI	-	NA	-	-

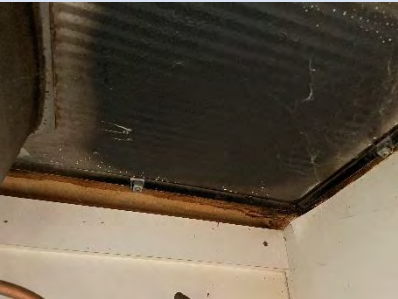
Material Identification		Risk Assessment			Risk Management & Corrective Actions			Photo
Location of Material	Description	Sample No.	Hazmat Detected / Identified	Quantity sqm, Lm, Unit	Friability	Risk Rating (H,M,L,N)		
Interior - Unit 3 - Kitchen - Under draining board - Damper	Sprayed bitumen	ASB05/R1	NAD	-	NA	-	-

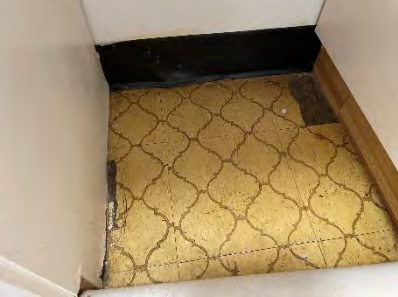
Interior - Unit 3 - Kitchen - Floor - Vinyl tiles under vinyl sheeting	Vinyl Tiles	ASB09	NAD	-	NA	-	-

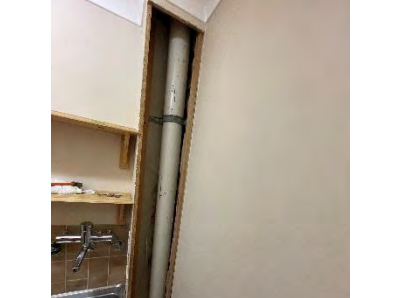
Interior - Unit 4 - Laundry - Riser	No hazardous materials	-	NHI	-	NA	-	-

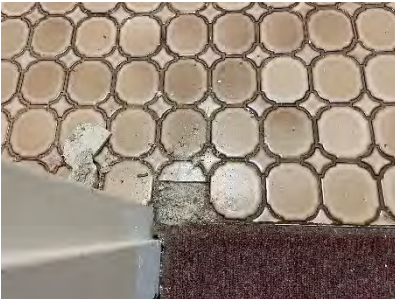
Material Identification			Risk Assessment			Risk Management & Corrective Actions		Photo
Location of Material	Description	Sample No.	Hazmat Detected / Identified	Quantity sqm, Lm, Unit	Friability	Risk Rating (H,M,L,N)		
Interior - Unit 4 - Bathroom, Laundry and Kitchen - Floor	Ceramic tiles with concrete below	-	NHI	-	NA	-	-

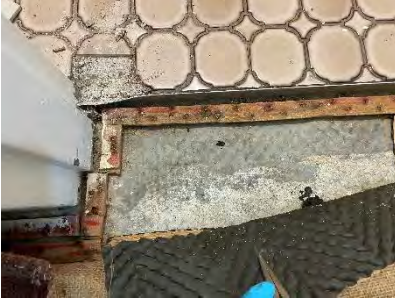
Interior - Unit 4 - Living and bedrooms - Floor - Under carpet	Concrete	-	NHI	-	NA	-	-

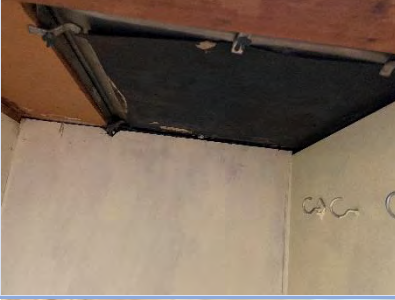
Interior - Unit 4 - Kitchen - Under draining board - Damper	Bitumen	ASB08	NAD	-	NA	-	-

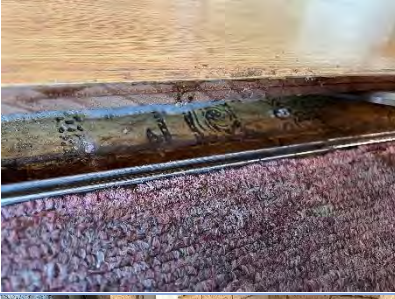
Interior - Unit 4 - Kitchen - Floor - Vinyl tiles under timber floorboard panels	Vinyl Tiles	ASB07/R1	NAD	-	NA	-	-

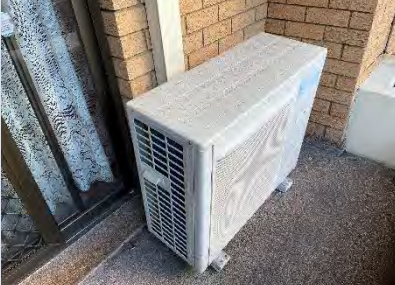
Exterior - Unit 4 balcony - Airconditioning unit	Refrigerant	ODS1	NHI	-	NA	-	Refrigerant R410a - Non ozone depleting substance

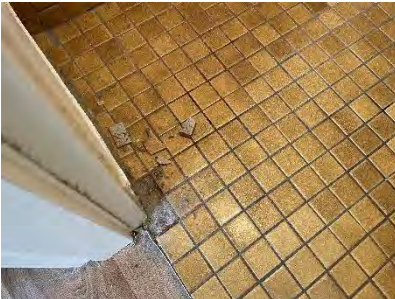
Material Identification		Risk Assessment			Risk Management & Corrective Actions			Photo
Location of Material	Description	Sample No.	Hazmat Detected / Identified	Quantity sqm, Lm, Unit	Friability	Risk Rating (H,M,L,N)		
Interior - Unit 5 - Bathroom, Laundry and Kitchen - Floor	Ceramic tiles with concrete below	-	NHI	-	NA	-	-

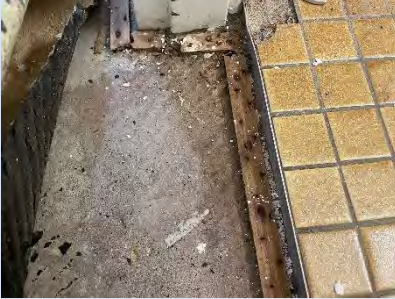
Interior - Unit 5 - Living and bedrooms - Floor - Under carpet	Concrete	-	NHI	-	NA	-	-

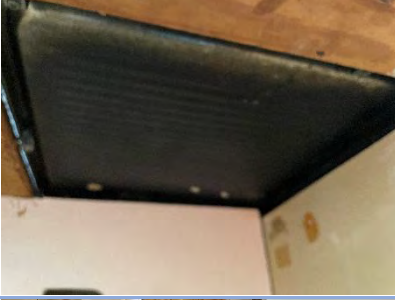
Interior - Unit 5 - Kitchen - Under draining board - Damper	Sprayed bitumen	ASB05	NAD	-	NA	-	-

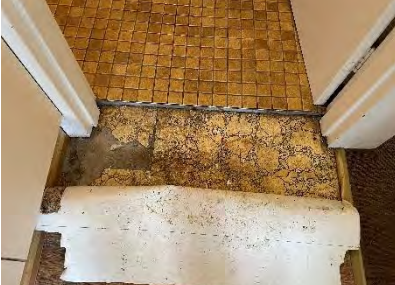
Interior - Unit 5 - Kitchen - Floor - Vinyl tiles under vinyl sheeting	Vinyl Tiles	ASB06	NAD	-	NA	-	-

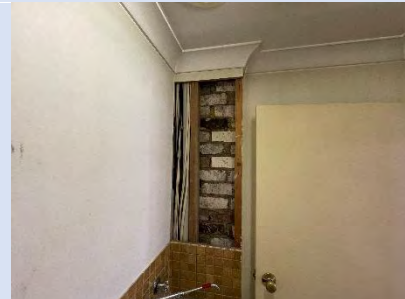
Material Identification		Risk Assessment			Risk Management & Corrective Actions			Photo
Location of Material	Description	Sample No.	Hazmat Detected / Identified	Quantity sqm, Lm, Unit	Friability	Risk Rating (H,M,L,N)		
Interior - Unit 6 - Laundry - Riser	No hazardous materials	-	NHI	-	NA	-	-

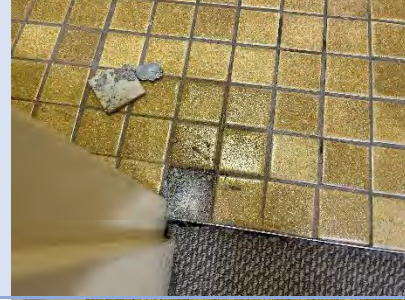
Interior - Unit 6 - Bathroom, Laundry and Kitchen - Floor	Ceramic tiles with concrete below	-	NHI	-	NA	-	-

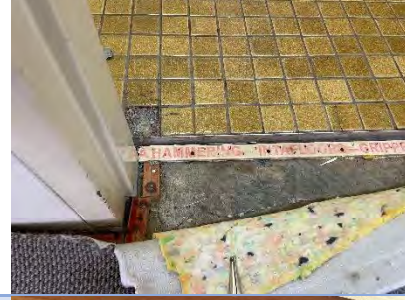
Interior - Unit 6 - Living and bedrooms - Floor - Under carpet	Concrete	-	NHI	-	NA	-	-

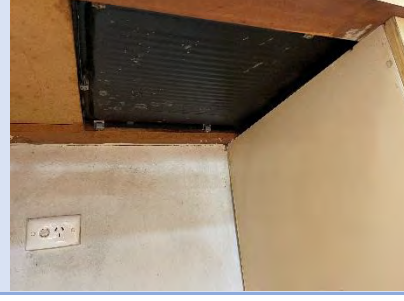
Interior - Unit 6 - Kitchen - Under draining board - Damper	Sprayed bitumen	ASB03	NAD	-	NA	-	-

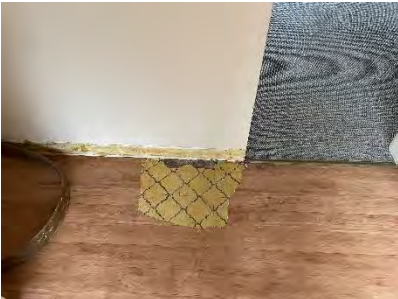
Interior - Unit 6 - Kitchen - Floor - Vinyl tiles under vinyl sheeting	Vinyl Tiles	ASB07	NAD	-	NA	-	-

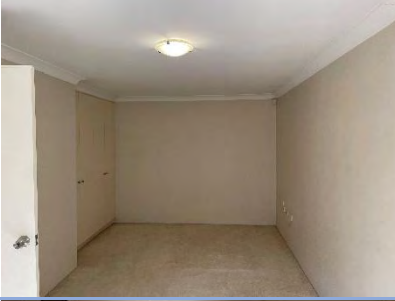
Interior - Unit 7 - Doors, door frames and skirting boards	Cream Paint	PB02	0.11% Lead in Paint	TH	NA	Low	Maintain material in good condition and dispose of appropriately prior to demolition.
